2000–2008 Chevrolet Trucks

Belt Tensioner

GLOBAL PARTS DISTRIBUTORS, LLC

Tech Tip

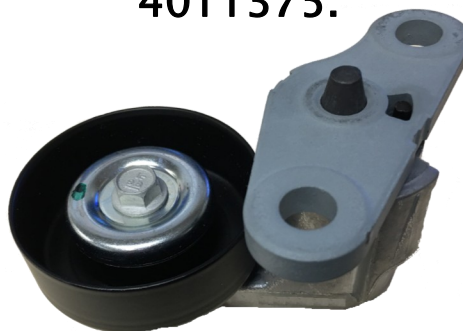
Did you know that if the compressor failed due to liquid slugging, it will cause premature failure of the belt tensioner? This failure could cause an under the hood rattling noise on 2000–2008 Chevrolet Trucks. Liquid Slugging has been known to cause A/C compressor failure, which results in the need of a new compressor. If the belt tensioner and serpentine belt are not replaced at the same time, it may generate a noise under the hood. This noise can be mistaken for a premature compressor failure. The typical life of a belt tensioner is 60,000 miles. Some common causes for the replacement of the belt tensioner are: loss of tension, bad bearing or a damaged pulley.

The gpd part number for the belt tensioner is
4011375.

We highly recommend checking this tensioner anytime you service a 2000–2008 Chevrolet truck.
