# 2007–2019 Nissan Compressor Wiring Harness Troubleshoot

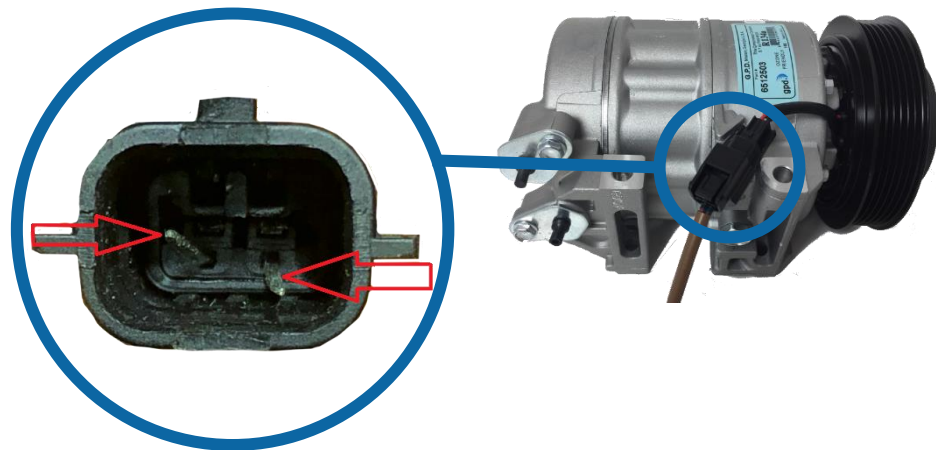
A common issue has been noted regarding the OE electrical connector/compressor pigtail on late model Nissan vehicles. The electrical connector (on the wiring harness side that plugs into the compressor) becomes loose after being separated and plugged back in. This electrical issue often leads to a malfunctioning A/C system.

Thoroughly inspect the wiring harness connectors before installing. Make sure to inspect the terminal inside of the electrical connector. In some cases, the terminals

gpd Compressor Pigtail Replacement
