2014–2018 BMW X5 and 2015–2018 BMW X6 Blower Motor Equipped with Resistor: 2312001

TECH TIP

#161

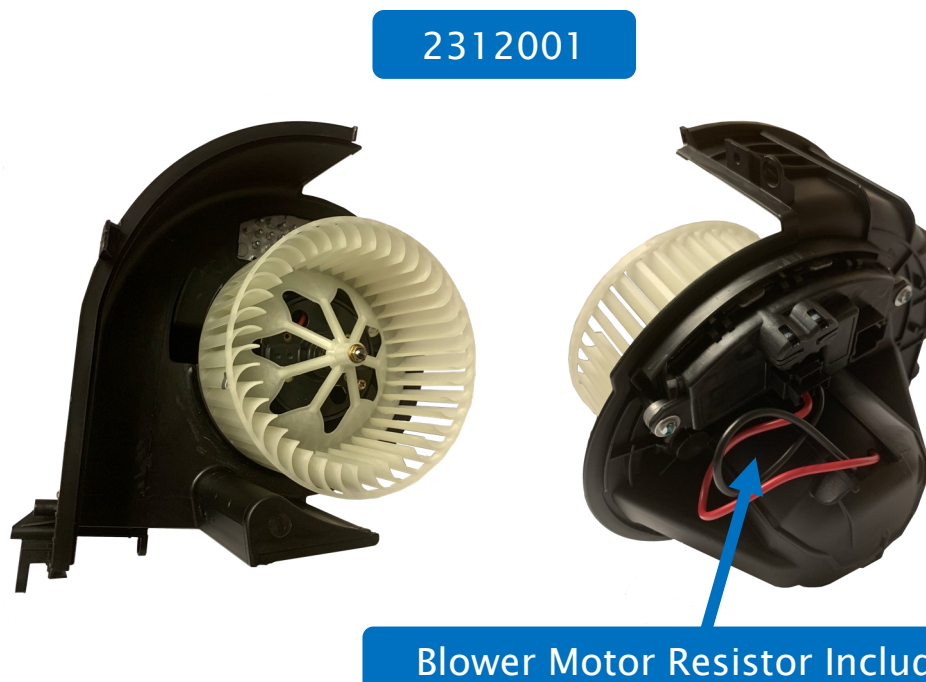
A common reason for blower motor failure is a faulty blower motor resistor. The blower motor resistor controls the speed of the blower motor to reduce/increase air flow based on A/C control commands. Most blower motors do not come equipped with the blower motor resistor; it is usually purchased separately. It is best practice to check/replace the blower motor resistor and connector/relay when replacing the blower motor. Considering the time to replace a blower motor takes approximately 2–3 hours, making these replacements a nominal cost and easy preventative measure.

gpd blower motor #2312001 for 2014–2018 BMW X5 and 2015–2018 BMW X6 comes fitted with the blower motor resistor.
