Have you experienced an issue with the blower motor speed selection on a Ford Ranger 1983–2005?

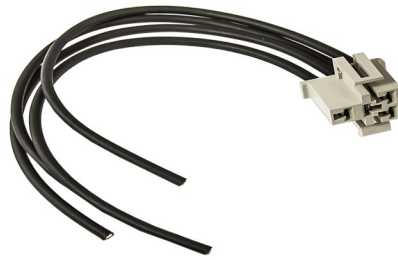
Have you experienced an issue with the blower motor speed selection on a Ford Ranger 1983–2005, or Explorer 2002–2005? The most likely problem is the blower motor resistor has failed and will require replacement. Another common problem is the electrical connector to the blower motor resistor may have a short causing the socket connection to melt.

The 1712270 is a replacement electrical connector that can be used to replace the burnt socket. Using the information below, you can cut out the old electrical connector and crimp this in its place.
