## Have you experienced an issue with the blower motor speed selection on a Chevrolet Express Van?

Have you experienced an issue with the blower motor speed selection on a Chevrolet Express Van (1996–2005) or a GMC Savana (1996–2005)?

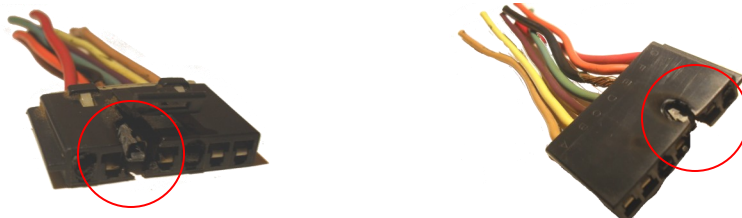
The most likely problem is the blower motor resistor has failed and will require replacement. Another common problem is the electrical connector to the blower motor resistor may have a short causing the socket connection to melt.

The 1711755 is a replacement electrical connector that comes with the same color coding as the OE wiring harness and includes heat shrink over the butt connectors. All you need to do is cut the old electrical connector out, match the wire colors together, then crimp the connectors. Finally, using a heat source, shrink the tubing over the connectors to provide a waterproof seal.
