# 1999–2020 Chevrolet Express Van/GMC Savana Blower Motor Speed Selection Troubleshoot

TECH TIP

#88

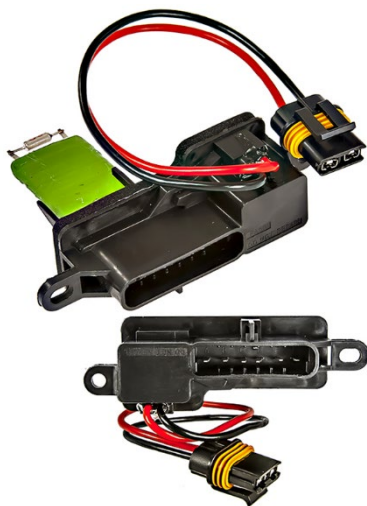
1712229  
Blower Motor Resistor

Blower motor resistor 1712229 is a direct fit blower motor resistor replacement with two hole mounts.
