# 1999–2006 Chevrolet Silverado/Suburban and GMC Envoy/Trailblazer Blower Motor Speed Selection Troubleshoot

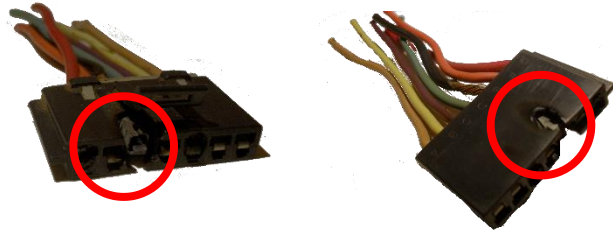
The most likely problem is the blower motor resistor has failed and will require replacement. Another common problem is the electrical connector/blower motor resistor pigtail connected to the blower motor resistor may have a short causing the socket connection to melt.

Signs of a short can be noticed by melted plastic components.
