GLOBAL PARTS DISTRIBUTORS, LLC

Tech Tip

2006–2014 VW Jetta Diesel Compressor Drive Pulley

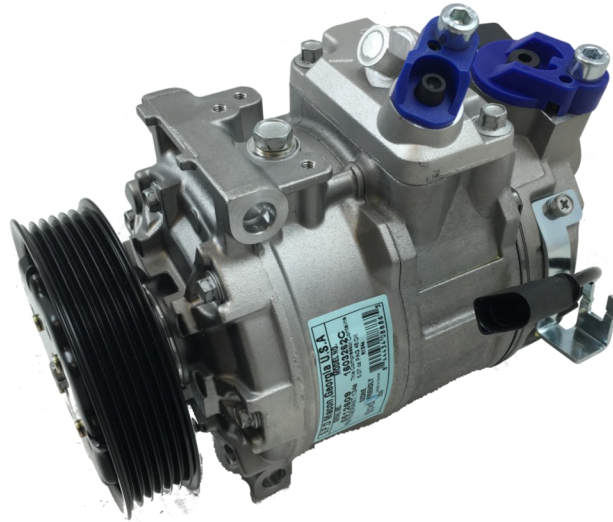
Are you working on a 2006–2014 VW Jetta Diesel that has come in for repairs with a compressor drive pulley that has sheared and is spinning freely? There may be more to look at than the air conditioning system. These vehicles are equipped with an alternator decoupler pulley. This decoupler pulley is designed to transfer torque from the engine to the alternator from the pulley. It then “over runs” during deceleration to help run the alternator. It is also designed to absorb engine vibrations.

When the decoupler pulley becomes worn, it can create a whiplash effect. This whiplash effect caused extra tension on the compressor’s pulley. Due to the extra tension, the pulley can begin to shear and break free. When replacing this compressor, it would be good practice to replace the alternator decoupler pulley as well in order to reduce the possibility of a future comeback.
