Replacing Parallel Flow Condensers when a Compressor Fails

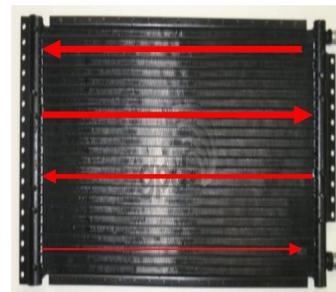
When a compressor fails the question for most technicians is whether to flush the condenser or replace it. For tube and fin condensers or serpentine condenser the choice is not difficult, the internal tube diameter is wide enough to be able to flush material through it to ensure the inside is clean and free of contaminants. On vehicles fitted with parallel flow condensers, usually around 1994 with the introduction of R134a, the choice is not as easy. The parallel flow condenser is a highly effective heat exchanger that divides the unit into sections or “passes” which creates a more efficient process for the refrigerant to change state from gas to liquid.

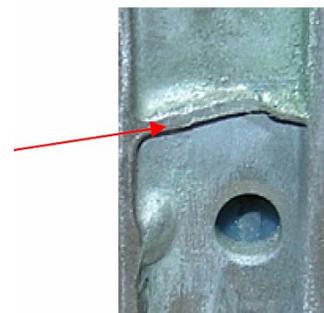
This is done by making the refrigerant change direction by 180° at the end on the side rails by placing a plug inside the rail at intervals, forcing the refrigerant change directions. The more plugs, the more times the refrigerant changes direction. In most condensers the refrigerant makes three to four “passes” through the condenser.

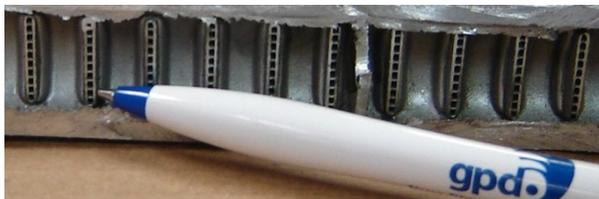
Parallel flow condensers don't have a large hollow tube that the refrigerant flows through, but a series of very small tubes close together in a row with the internal diameter about the size of a pin head. This helps to improve the surface area of the condenser and increase its cooling capacity.

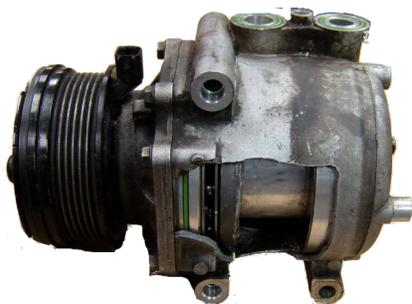
When a compressor fails it introduces contaminants into the system, one of the easiest ways to spot this is to remove the orifice tube that usually reveals metal deposits or sludge from a faulty compressor. The metal and sludge gets deposited throughout the system and will collect at places in the system with restrictions, like the orifice tube and on later model vehicles, the parallel flow condensers.

While flushing the system can help to remove debris from part of the system, items with small openings, like the parallel flow condenser are going to collect the debris. Flushing them will only push the contaminants further into the condenser and will collect at the plugs in the side rails, reducing the amount of rows available to cool the refrigerant and slowing the flow of the refrigerant, this leads to high head pressures. Combine it with a high efficiency compressor, like a scroll and not only will the replacement compressor fail, but it may be a catastrophic failure.

When confronted with a compressor failure on a vehicle fitted with a parallel flow condenser, we recommend that the technician replace the accumulator, orifice tube or expansion device and condenser. We also recommend that all other components are flushed to ensure they are free of contaminants that could harm the new compressor.
