# Nissan Compressor Issue/ Wiring Harness

GLOBAL PARTS DISTRIBUTORS, LLC

## Tech Tip

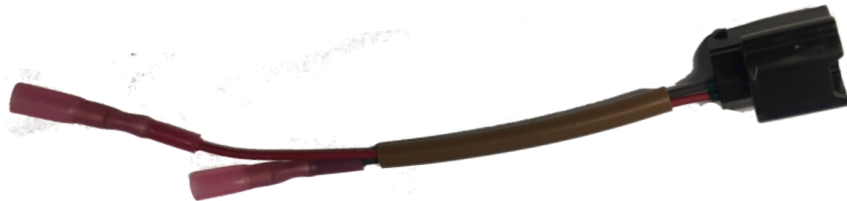
We are noticing an issue with the OE electrical connector on late model Nissan vehicles. The electrical connector, on the wiring harness side that plugs into the compressor, becomes loose after being separated and plugged back in. Pay close attention to the wiring harness when connecting to the new compressor, making sure you have a good connection.

Replacement electrical wiring harness plugs are available,  
gpd # is 1712339.

Please check this connection after compressor installation. If you need a new connector the gpd part number is #1712339.
