# Check the Blend Door Position Before Installing a New Blend Door Actuator

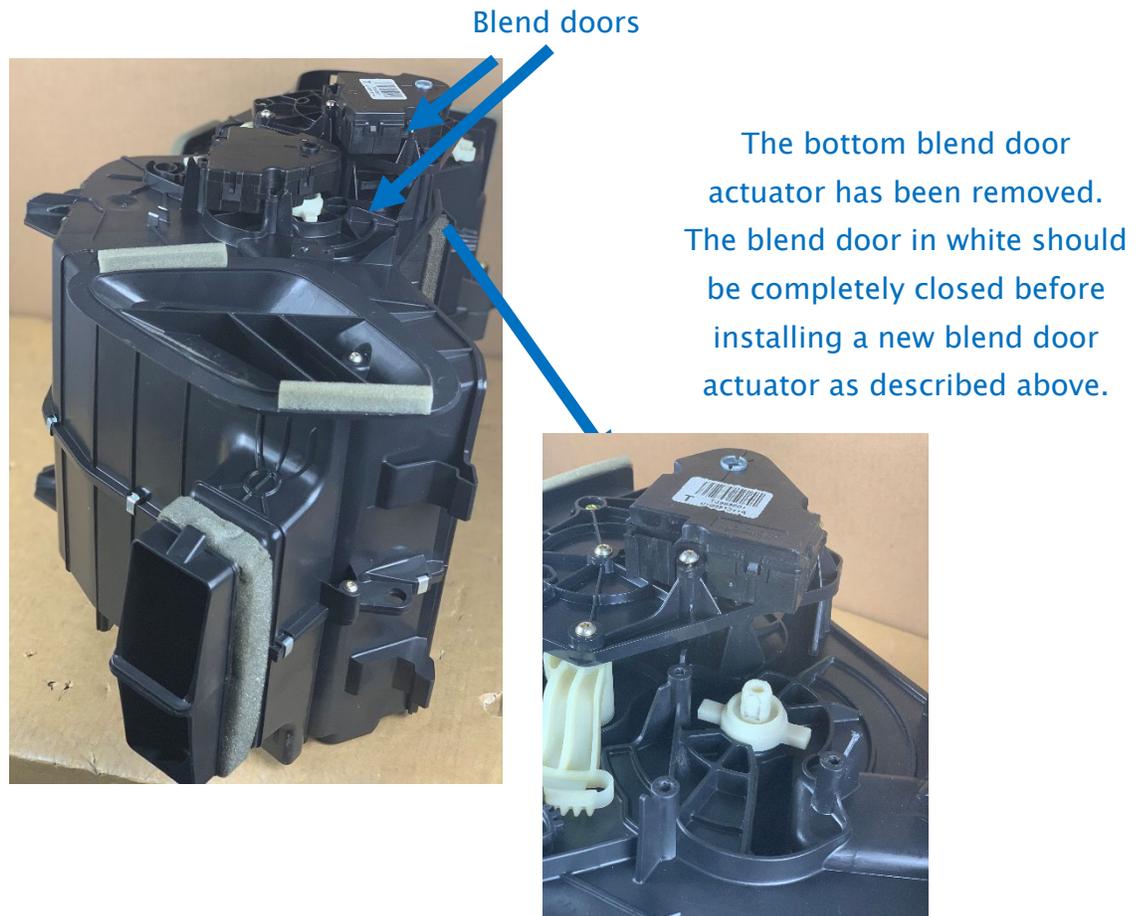
Shown is the HVAC housing for a 2010 Chevrolet Traverse:

If replacing a blend door actuator, check to make sure the blend door position is completely closed before installing the new blend door actuator. If the blend door is left open, even slightly, the temperature inside the vehicle will not match the A/C temperature selected.
