Subaru Piston Replacement Compressors: 6513347, 6513348, and 6513349

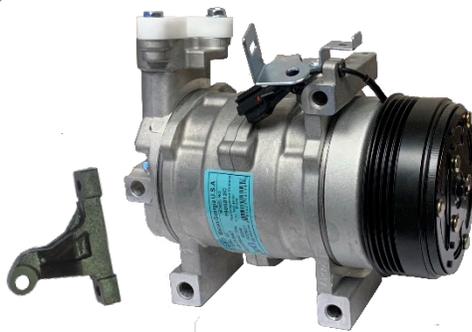
6513347

Includes Universal Bracket Replacement

Piston Replacement for 6512647

- 2007–2013 Subaru Forester
- 2008–2011 Subaru Impreza
- 2013–2014 Subaru WRX
- 2013–2015 Subaru WRX STI

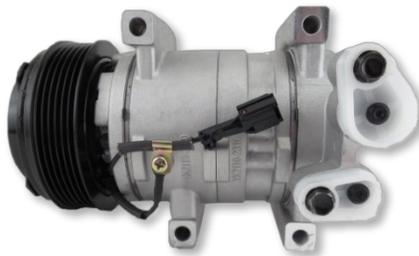
6513348

Piston Replacement for 7512978

- 2011–2013 Subaru Forester

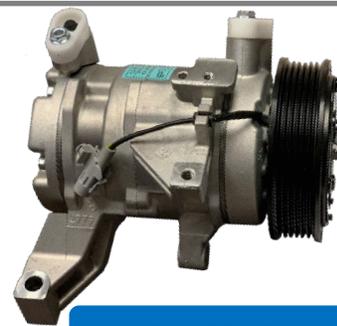
6513349

Piston Replacement for 7512979

- 2014–2018 Subaru Forester
- 2012–2016 Subaru Impreza
- 2015–2017 Subaru WRX
- 2013–2015 Subaru XV Crosstrek
