White Dust Blowing from Air Vents?

TECH TIP

#158

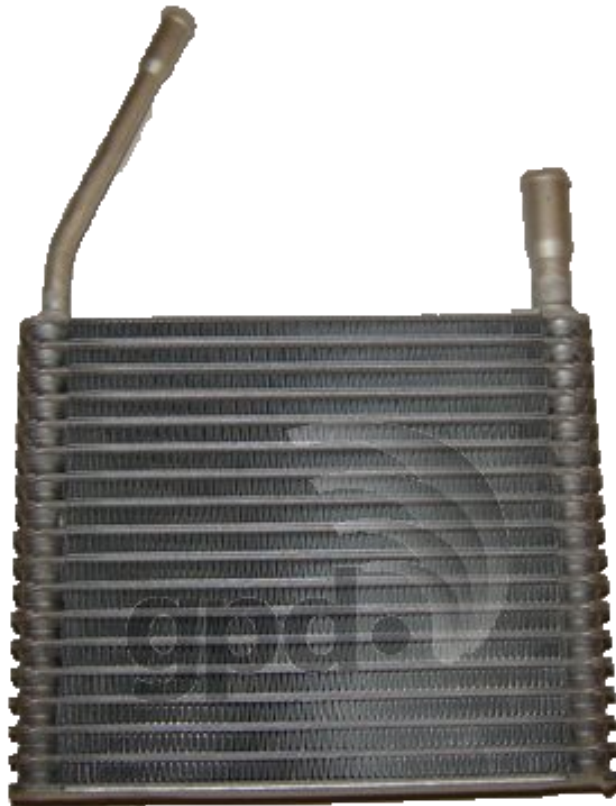
During production, the evaporator is coated with a protective laminate that can wear off over time. If a solid white powder/dust is blowing through the A/C vents into the passenger cabin, it is most likely residue from this laminate blown by the blower motor. It can also be an excess of flux used in the manufacturing process. This is not to be confused with a white colored cold mist that can be blown into the cabin by a frozen evaporator.

We recommend consulting an expert to assess the A/C system and decide if the evaporator needs to be replaced. While it is most likely laminate residue, there is a chance the source is debris or chemicals from another component.
