# Late Model Condensers Cannot be Flushed... Only Replaced

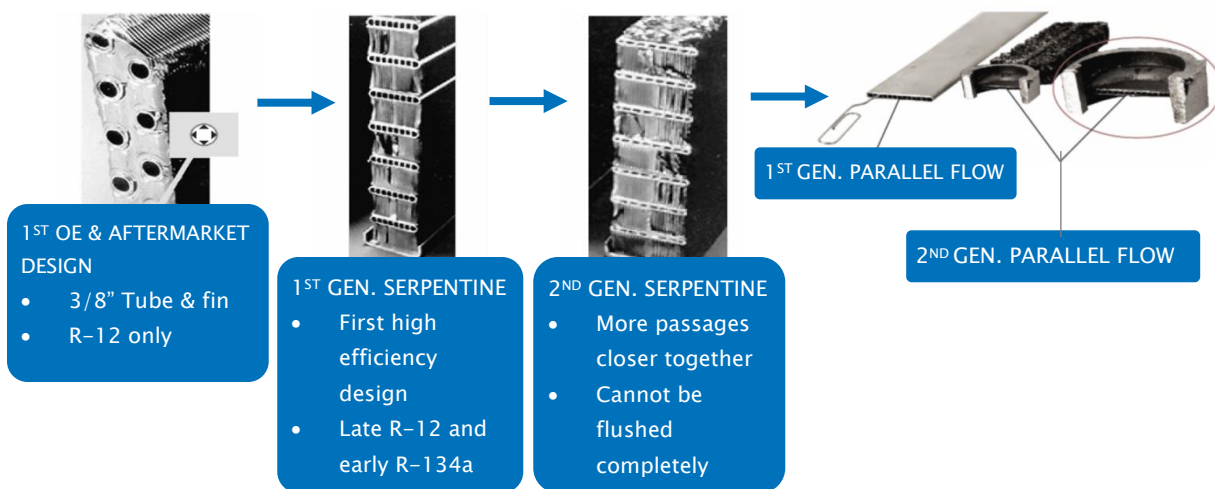
Most late model vehicles on the road today feature a parallel flow style condenser. Leading aftermarket suppliers have also adapted original serpentine and piccolo condenser styles to offer a more efficient parallel flow style replacement. It is important to note the refrigerant charge will vary based on condenser design and may need to be modified if replacing a factory condenser with an aftermarket parallel flow style condenser. Temperature testing is the best method to verify proper condenser charge. (For more information on verifying the right refrigerant charge, refer to gpd Tech Tip #169, "Check the Charge Before You Install")

Parallel flow style condensers feature a multi-channel construction with 400–600 small tubes that average less than 1mm in diameter. This design maximizes heat transfer because refrigerant cycling through the A/C system is dispersed across a greater surface area.

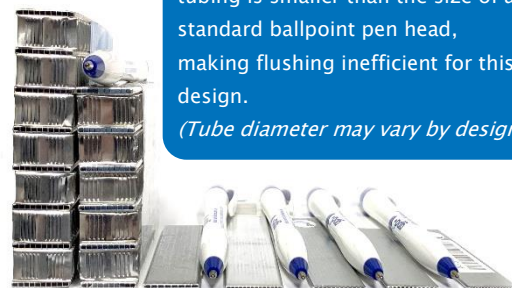
Although efficient for cooling, the small tubes mentioned above are so small (less than 1mm in diameter) that they trap any contamination in the system. Even small amounts of excess debris can restrict refrigerant flow, causing high head pressure and damage to the compressor. These restrictions are impossible to clear with flush, thus requiring a replacement condenser.

The average diameter of internal tubing is smaller than the size of a standard ballpoint pen head, making flushing inefficient for this design.  
(Tube diameter may vary by design)

gpd highly recommends flushing the system and replacing the condenser alongside the compressor because excess contaminant/debris left in the system from a failed compressor will cause a repeat failure.
