## Scroll Compressors

gpd #6511472

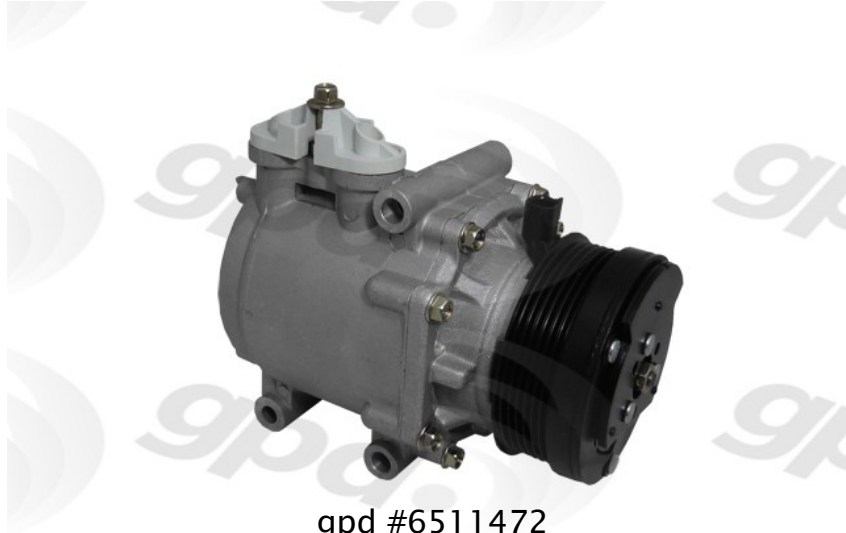
Following our Tech Tip on parallel flow condenser and scroll compressors, it is worth noting that scroll compressors come up as a topic of conversation with shops. Debris gets lodged in the A/C system after the original compressor has failed and a replacement compressor has been fitted. This happens because the debris from the original compressor gets lodged in the condenser and can cause the replacement compressor to experience a catastrophic failure. This will be noticeable as the replacement compressor fitted will have had holes and large cracks in the body of the compressor.

To avoid a warranty situation, remind your customers that we advise them to replace the following:

1. Compressor with Clutch
2. Condenser with Dryer (Condenser cannot be Flushed)
3. Expansion Valve
4. Seals and O-Rings
