# 1998–2005 Ford Ranger Blower Motor Speed Selection Troubleshoot

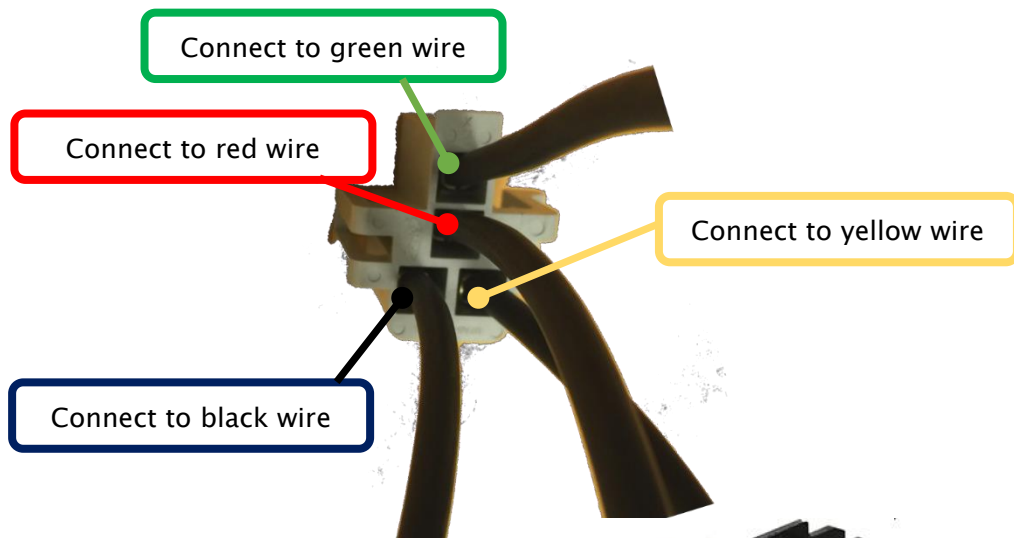
1712270  
Blower Motor Resistor Pigtail

The most likely problem is the blower motor resistor has failed and will require replacement. Another common problem is the electrical connector/blower motor resistor pigtail connected to the blower motor resistor may have a short causing the socket connection to melt.

gpd blower motor resistor pigtail 1712270 can be used to replace the burnt socket. The old blower motor resistor pigtail will need to be cut out and replaced with 1712270.

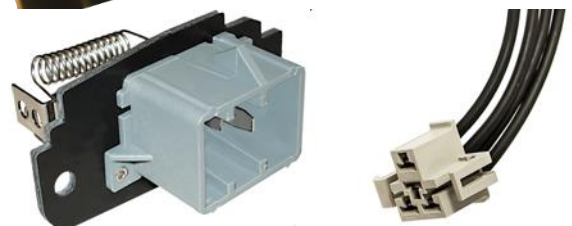
1711725  
Blower Motor Resistor

gpd blower motor resistor 1711725 is a direct fit replacement for the front blower motor resistor in both manual and automatic A/C systems. It has a two-hole mount.
