2006–2014 VW Jetta Diesel Compressor Drive Pulley 6512609

Tech Tip

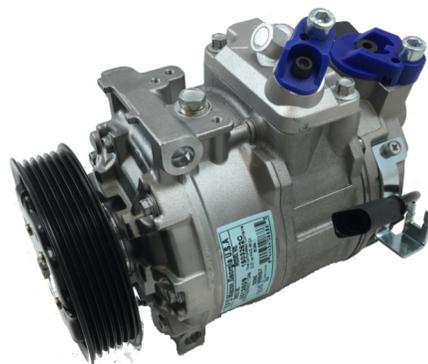
Earlier, we released a tech tip to highlight the issues with the 2006–2014 VW Jetta diesel compressor, 6512609. We noticed that this compressor was experiencing compressor drive pulley issues. The compressor drive pulley sheered between the clutch and drive shaft of the compressor, as they are designed to do if the compressor fails. The compressor pulley then runs free so that the engine can still operate and drive the vehicle.

We found that this was occurring due to the wear on the alternator decoupler over time, which generated a whiplash effect when the engine decelerated. The worn alternator decoupler created extra tension on the compressor pulley, causing it to shear.

In an effort to design a better compressor, gpd has improved the compressor drive pulley by adding extra strength and support to the compressor pulley to help ease the extra tension caused by a worn alternator decoupler.

We still recommend that you replace the alternator decoupler pulley when replacing the compressor, but the newly redesigned compressor clutch should give more support if the compressor experiences extra tension due to the diesel engine whiplash effect.
