Replacing Parallel Flow Condensers When a Compressor Fails

TECH TIP

#58

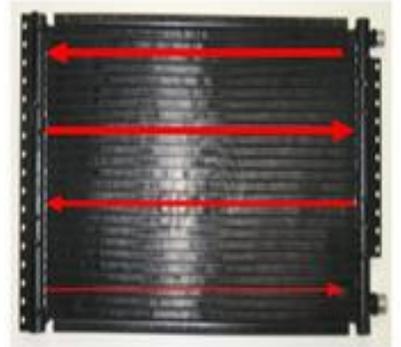
This is done by making the refrigerant change direction by 180° at the end on the side rails by placing a plug inside the rail at intervals, forcing the refrigerant change directions. The more plugs, the more times the refrigerant changes direction. In most condensers the refrigerant makes three to four "passes" through the condenser.

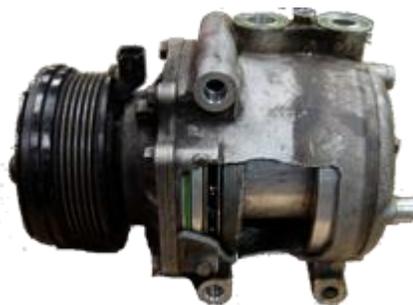
While flushing the system can help to remove debris from part of the system, items with small openings, like the parallel flow condenser are going to collect the debris. Flushing them will only push the contaminants further into the condenser and will collect at the plugs in the side rails, reducing the amount of rows available to cool the refrigerant and slowing the flow of the refrigerant, this leads to high head pressures. Combine it with a high efficiency compressor, like a scroll and not only will the replacement compressor fail, but it may be a catastrophic failure.

When confronted with a compressor failure on a vehicle fitted with a parallel flow condenser, we recommend that the technician replace the accumulator, orifice tube or expansion device and condenser. We also recommend that all other components are flushed to ensure they are free of contaminants that could harm the new compressor.
