Subaru Piston Replacement Compressors: 6513347, 6513348, and 6513349

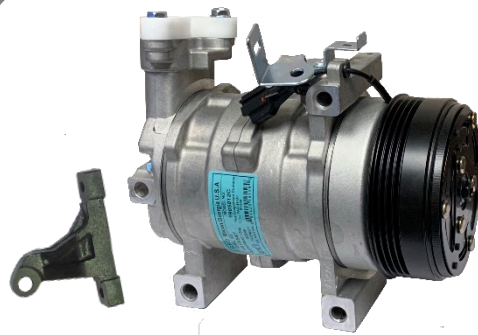
6513347

Includes Universal Bracket Replacement

Piston Replacement for 6512647

- 2007–2013 Subaru Forester
- 2008–2011 Subaru Impreza
- 2013–2014 Subaru WRX
- 2013–2015 Subaru WRX STI

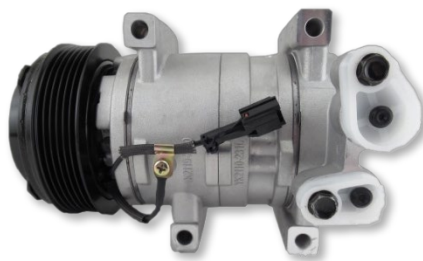
6513348

Piston Replacement for 7512978

- 2011–2013 Subaru Forester
