## Service Precaution: 2009–2018 Dodge Ram Heater Core Replacement: 8231500

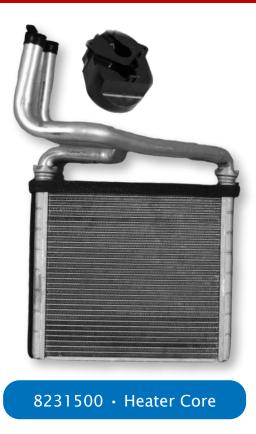
Take caution to avoid damaging fragile joints when installing gpd heater core 8231500 in a 2009–2018 Dodge Ram. This heater core features crimp style joints that can be easily damaged when disassembling and reassembling the HVAC housing. gpd recommends extreme caution when disconnecting/ connecting heater lines through the firewall. It is important to ensure the aluminum pipes are supported (best practice is to hold the pipes in one hand while refitting hose connections) during repair to avoid bending the aluminum lines. Bends in these lines, especially close to the crimped style joints, can cause the seal to leak.

## **CAUTION** Crimp style joints are fragile. Avoid damaging to prevent leaks.

**PRO TIP**: To access the heater core, the dashboard and HVAC housing must be disassembled and removed, making it a time-consuming repair. It is highly recommended to replace the evaporator core alongside the heater core.
