2015–2019 Ford Transit 3.2, 3.5, 3.7 Gas, Flex, Diesel & CNG Coolant Reservoir Tank

TECH TIP

#241

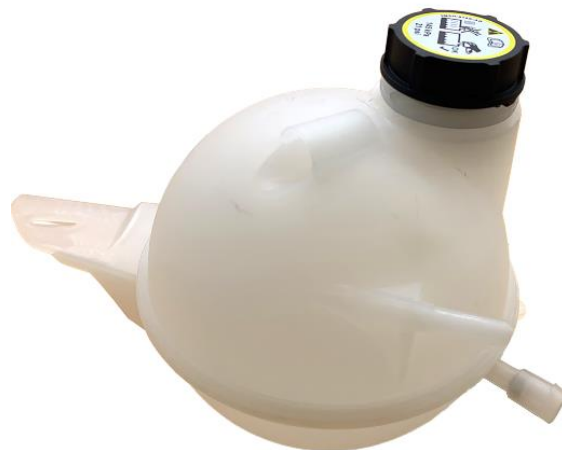
gpd 2411159
OE Fit, Form, Function

The Ford Transit, a widely used delivery vehicle, is known to have frequent issues with the Radiator Coolant Reservoir.

This issue is mainly caused by a few factors, with the vehicle's age being a key contributor. Ford Transits are driven for high mileage and experience significant heat in the engine bay. This is especially common in models with Ecotec or turbocharged engines, which generate a lot of heat, affecting both the coolant and the engine bay.

Excessive heat and the vehicle's age can cause the plastic to break down over time, leading to leaks. For peace of mind and to avoid further issues, it's best to replace the entire assembly.

Watch out for coolant leaks from radiator hoses, coolant joints, heater assemblies, and the radiator itself. Insufficient amount of coolant can cause serious engine damage. Always check the manufacturer's specifications to ensure you're using the correct coolant for the vehicle.
