Extend the Life of Your Condenser

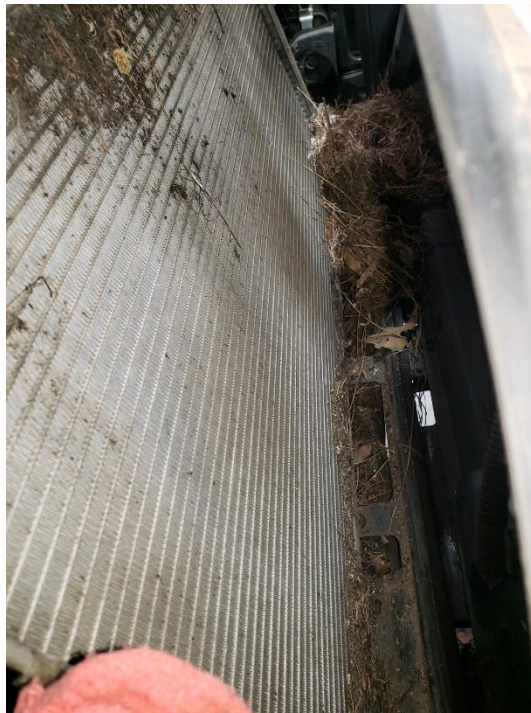
Extend the life of your condenser by cleaning out excess debris surrounding the system.

Before diagnosing an A/C system/ condenser, be sure to clear any surrounding debris, dust, trash, etc.

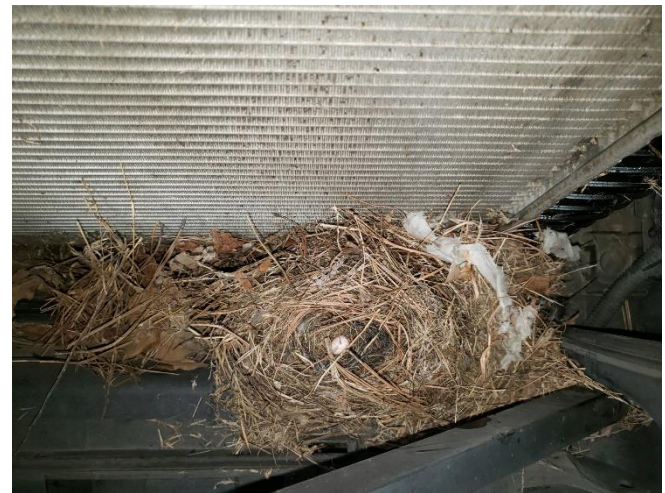
A cause of premature condenser failure is excess debris in and/or surrounding the condenser.
